A STUDY  
of  
IDEAL DRY PIPE VALVE

A T H E S I S

BACHELOR OF SCIENCE IN FIRE PROTECTION ENGINEERING

June 1, 1906.

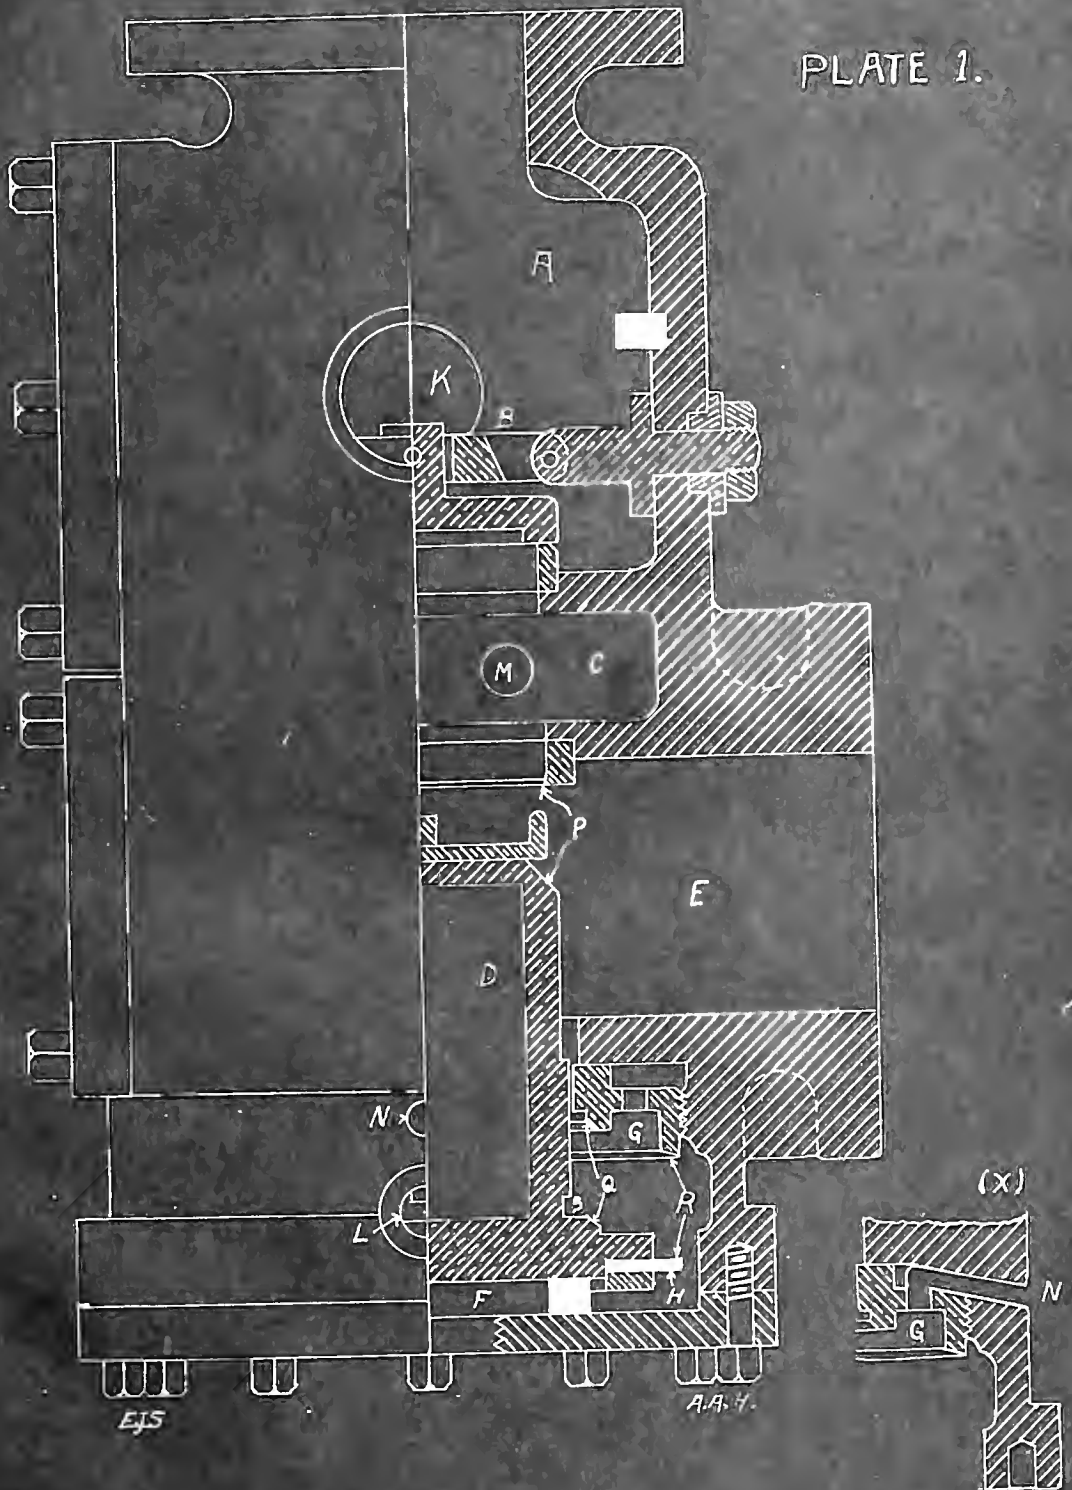
PLATE 1.

The blue print on page ( 9 ) shows the first pattern of the valve in cross section. It is divided into five (5) chambers,- A, C, E, F and G. A and F are connected by a  $3/4$ " pipe and are under air pressure; chamber E is under water pressure, and chambers C and G are connected by a  $1/2$ " pipe which is vented to the atmosphere. The connection between C and G is not altogether plain on account of the blue print not showing any direct connection between N and G. As shown, G apparently opens through a  $3/8$ " hole into a channel, which is vented through K. However, this is better shown in X, which is a cross section through N, and shows that the opening above G is not a channel. In the body of the valve are two moving parts,- clap valve B which separates A and C, and movable member D, which is a solid brass shell weighing  $20\frac{1}{2}$  13.5 oz. when empty and  $23\frac{1}{2}$  14.5 oz. when full. On this brass valve are two rigid faces (P) - (Q), and one flexible rubber face (H). The two rigid faces are ground to fit the brass seats (P-Q) after the latter are in position in the cast iron body, and form the shut-off against the water pressure when the valve is set.

The results of the tests made in 1903 and early in 1904 show that there is something radically wrong with the first pattern. In "firing" with water pressures around 50#, the movable member apparently does not drop to the end of its travel, but merely opens a short distance and is immediately slammed back on its seats. When the amount of flow through the riser was small, the pressure in (A) slowly became equal to that in (E), and when the discharge from the riser was quickly opened a heavy water hammer was noted. Numerous theories could be brought forward to account for this action, but probably one as satisfactory as any is this:- When the valve is near the "firing" point, that is, when the total pressure on the lower part of (D) in chamber (F) approaches the total pressure acting downward on (D) in chambers (C) (E) and (G), water begins to creep past seats (P) and (Q), and, as the vent for chambers (C) and (G) is small, the pressure accumulates in both chambers, but more rapidly in (G) than in (C), on account of the larger diameter of the seat (Q). Now this pressure in (G) passes seat (R) and accumulates in (F), with the result that (D) is prevented from falling until the pressures in the different chambers are equalized, which, when the passage from (F) to (A) is restricted in any way, can only occur slowly, or not at all when the passage is restricted and the discharge opening from (A') is large. However, if the pressures do become equalized, (D) does apparently drop to the end of its travel, otherwise, there could be no heavy water hammer when the discharge from (A)

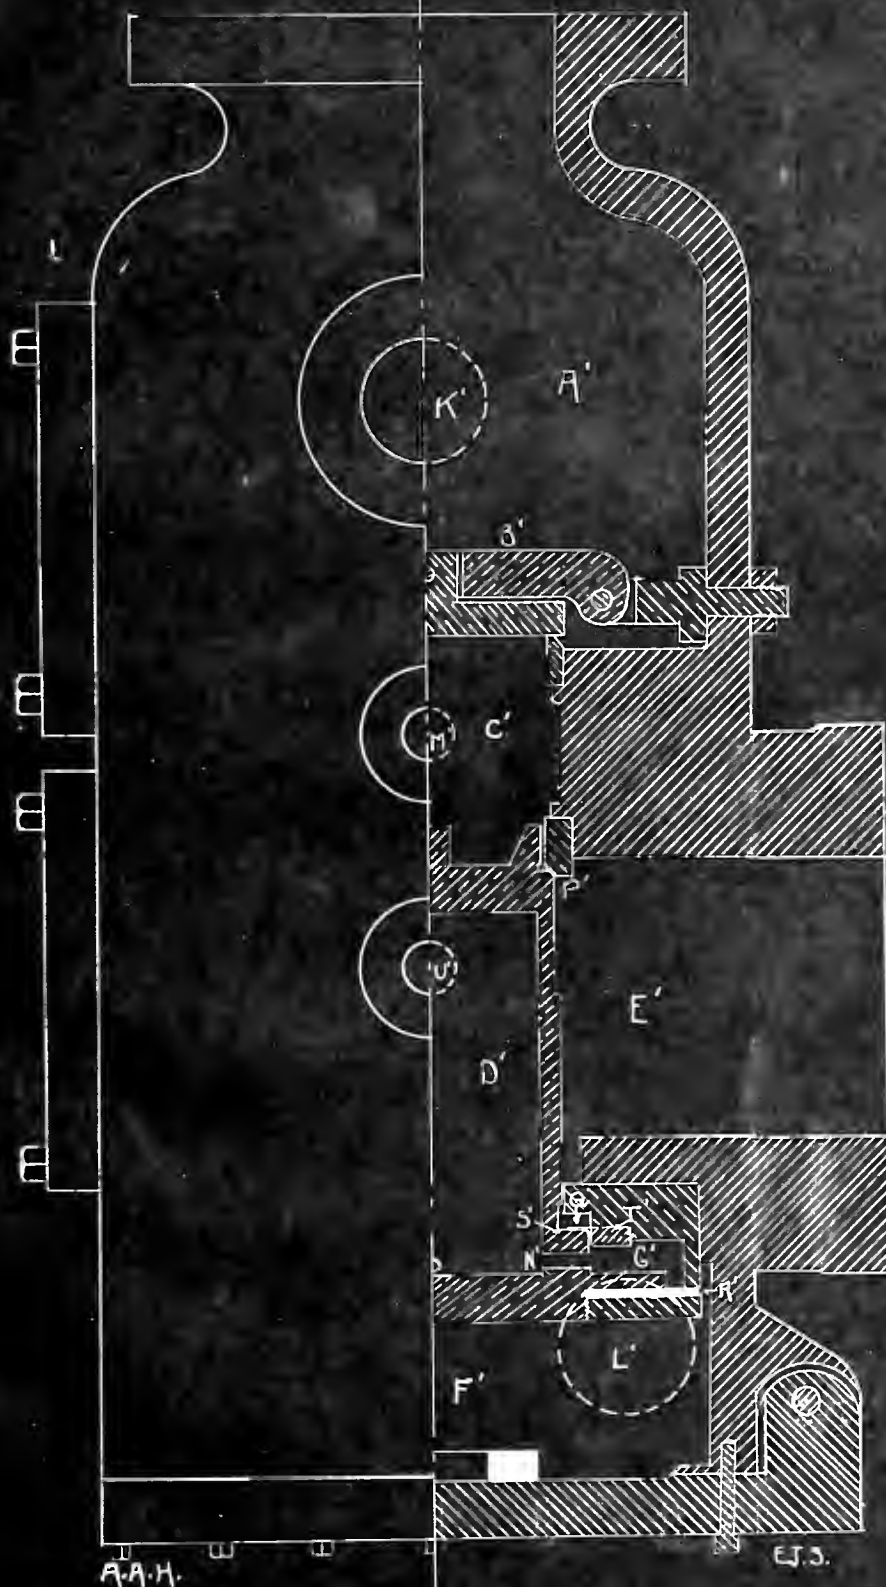
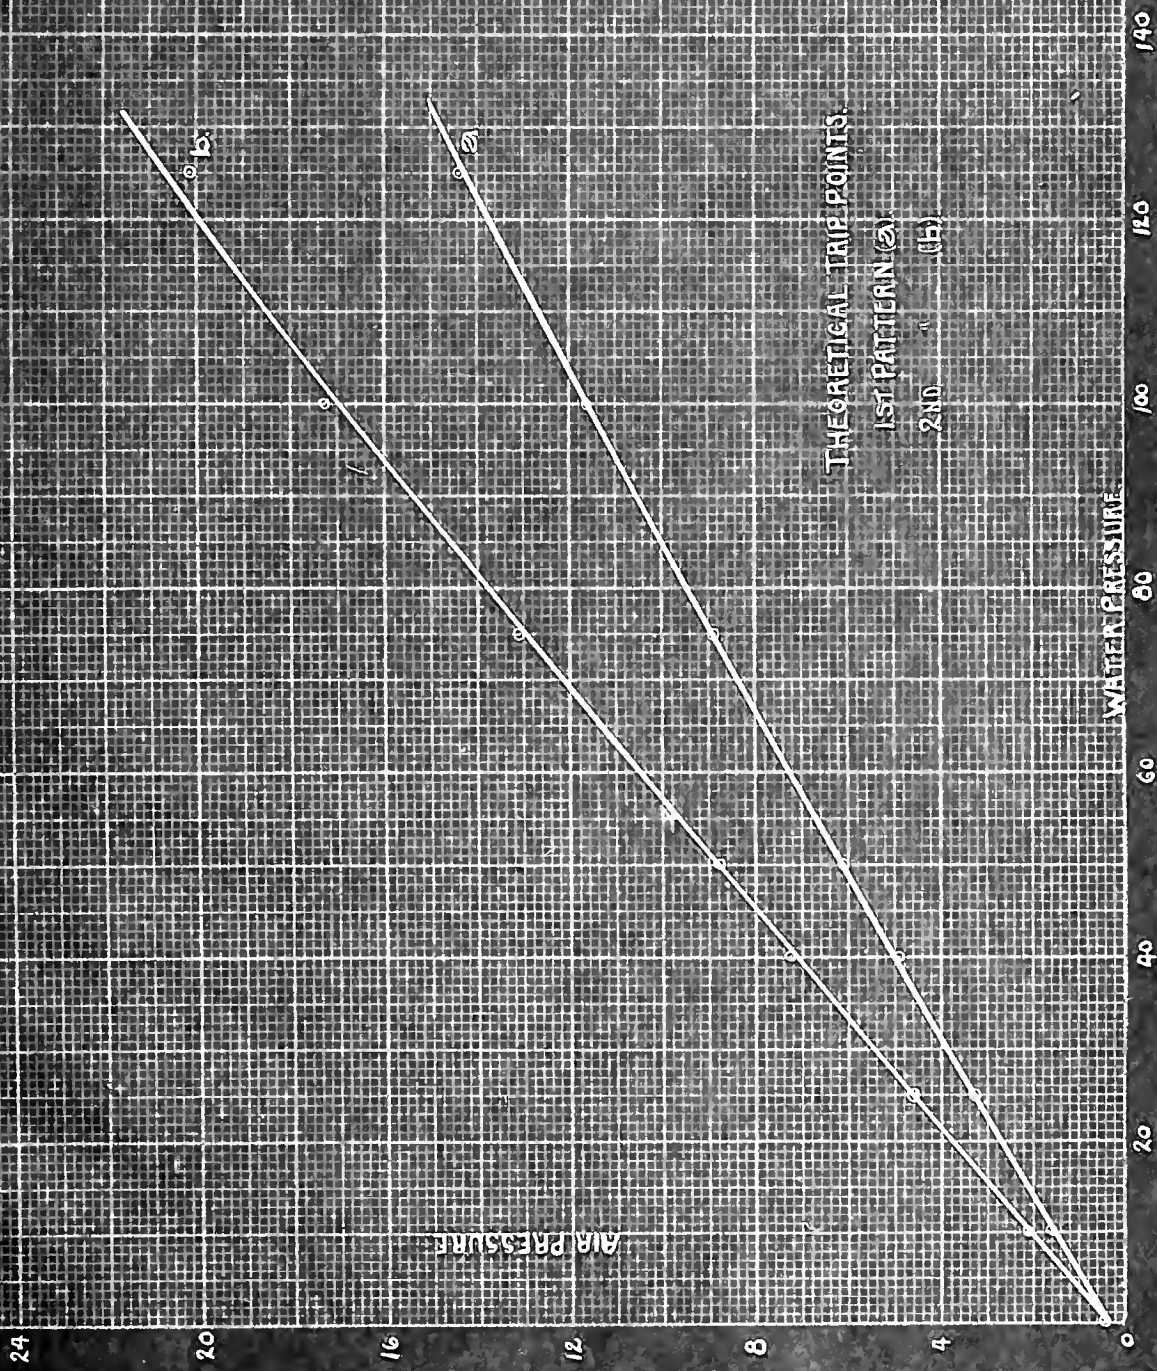
PLATE 2.

The second pattern submitted works on the same principle, but differs in construction. Instead of having two rigid seats, this pattern has the lower seat (Q) replaced by a brass diaphragm, and has the chambers connected differently.

(A') and (B') are connected by a 2" pipe, and (C') connects through the body of the moveable member, with (G') and is vented to the atmosphere. The dimensions of the two valves differ somewhat, but not in a way to materially affect the operation. On page (2-) is given a dimensional comparison of the two valves.

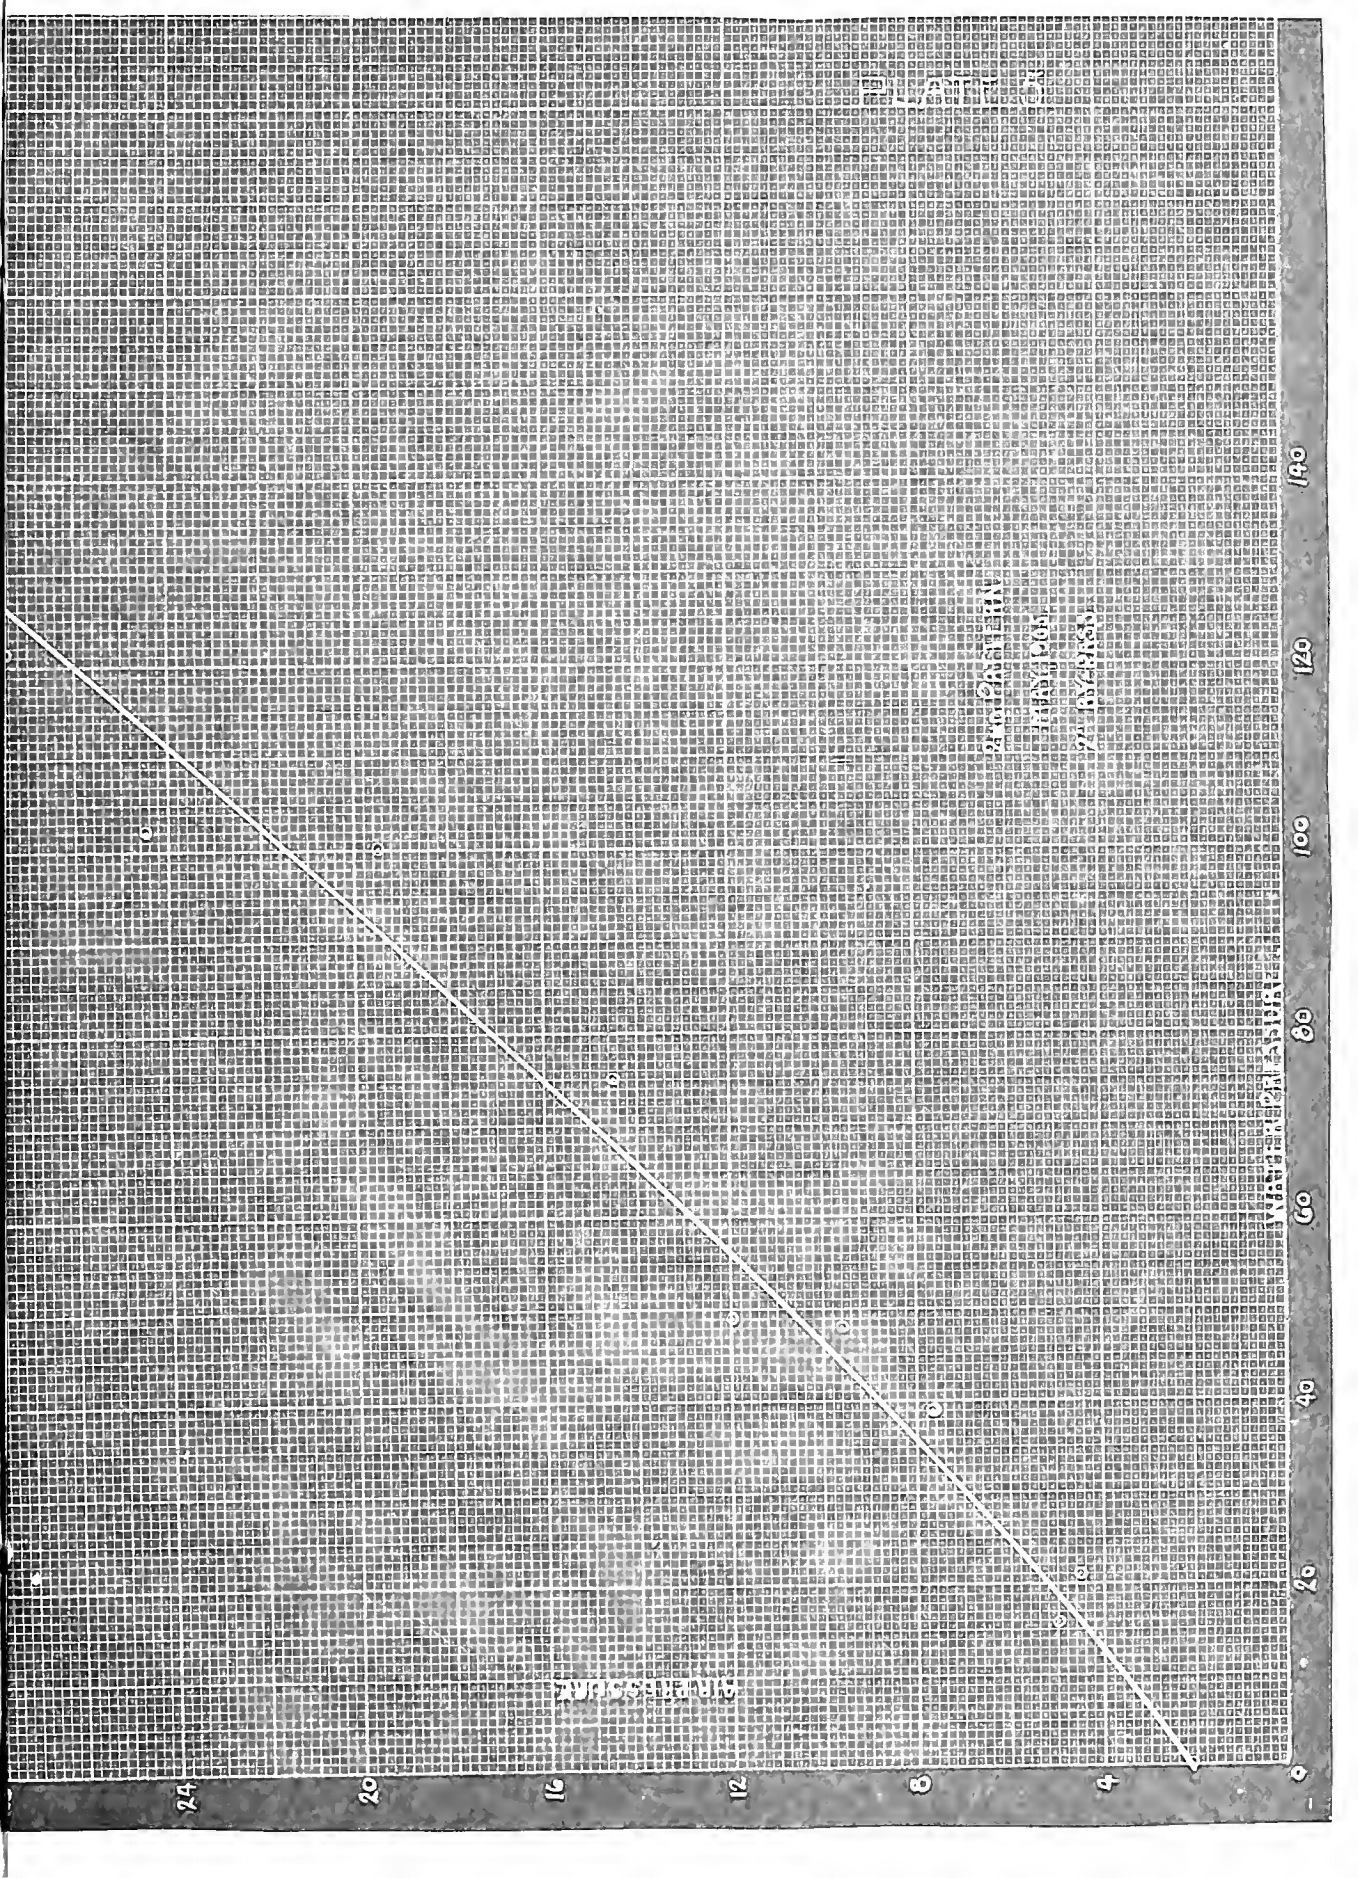
FIRST PATTERN. (3/4" By-Pass).

Water hammer occurred at 38#, 58#, 67#, 87#, 113.8# water pressure. At all other pressures above 25#, movable member found jammed. Time necessary for system to equalize varied from 50 to 70 secs. Water hammer was also produced on suddenly opening discharge valve at those pressures where water hammer occurred on "firing". At the pressures which the movable member jammed, no water hammer resulted on suddenly opening the discharge valve. No doubt the jamming of movable member on "firing" prevented this, as will be seen later on. The seats leaked badly at all pressures. On account of the tendency of the movable member to stick on "firing", a series of tests were made with movable member not set but resting on bottom of chamber (F). The water pressure was raised to 80#. The discharge valve was suddenly opened. The object of this series of tests was to pick up movable member and produce water hammer.

water hammer in system, as shown by violent fluctuation of gauge needles. The probable reason for water hammer is the accumulation of pressure in chamber (F). Water hammer starts in at about 40#, never below this pressure. At the higher pressure the hammer is so violent as to injure the seats, which partly accounts for their poor condition.

The trip points are fairly uniform. The curve drawn through these points is very much steeper than the theoretical curve; also very much steeper than the curve obtained from the tests made at the Underwriters' Laboratories in September, 1903 and January, 1904.

The increase in air pressure necessary to hold movable member against water pressure is due to corrosion and wear of seats. The violent water hammer to which the valve has been subjected during the 3 years test at the laboratory has injured the seats to a marked extent, and thus a higher air pressure is necessary to make the seats tight.

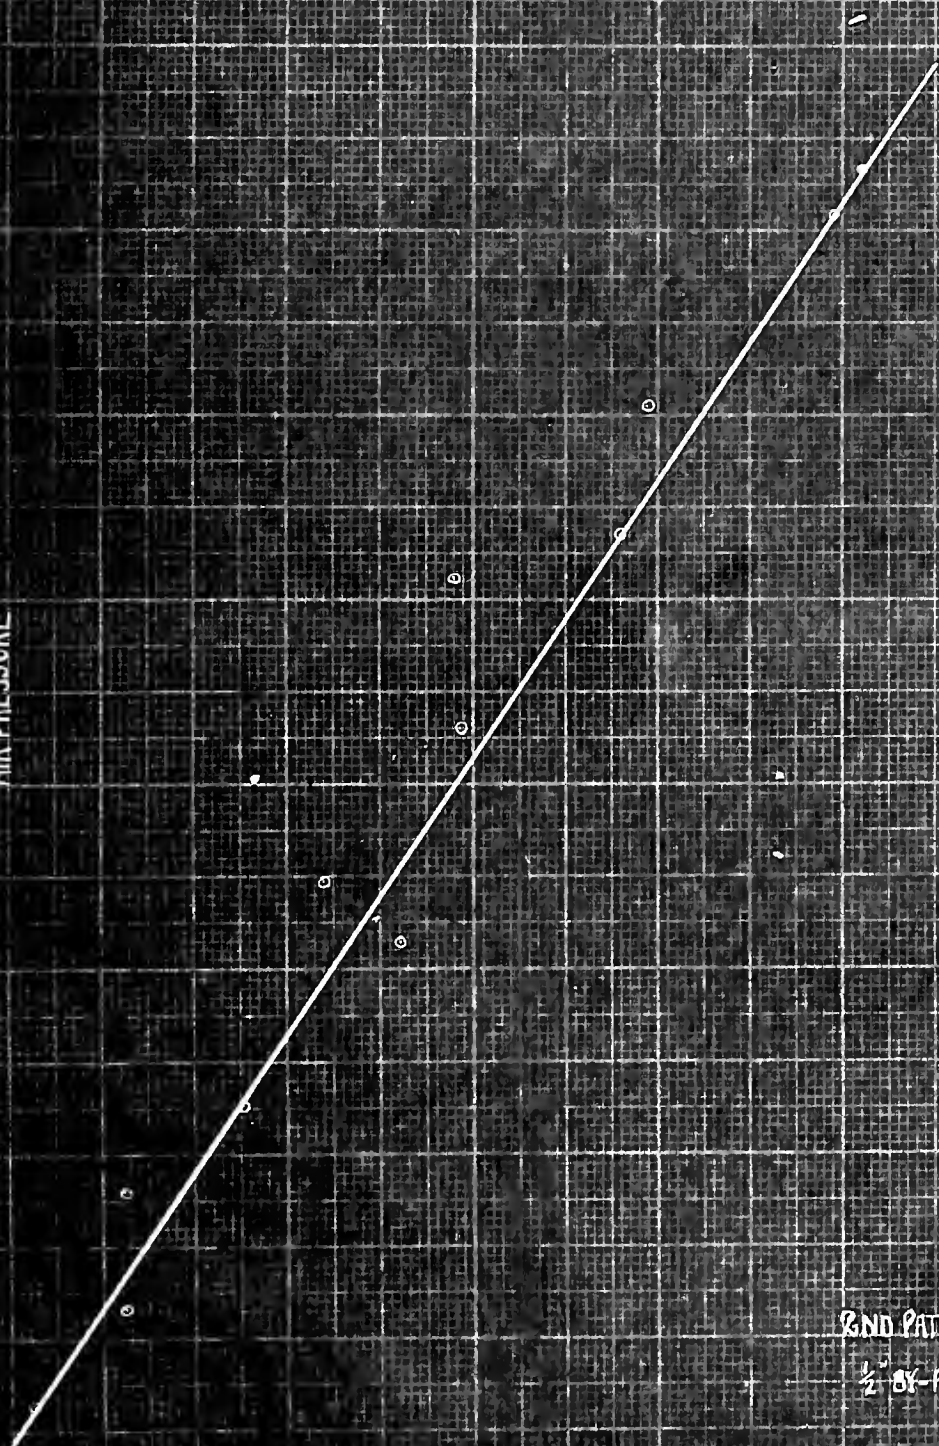
2ND PATTERN  
 $\frac{1}{2}$  OR-PASS

SECOND PATTERN (3/4" By-Pass).

Water hammer occurred 77# and 101# of a very violent nature. At 113.5# no water hammer, but movable member found stuck, which accounts for lack of hammer at this high pressure. System equalizes in 10 to 35 seconds. No water hammer observed on opening discharge valve. Mercury gage readings vary from 9.6# to 23.7# on "firing", and from 4.5# to 10.7# on opening discharge valve. From the results of the data it is apparent that the critical point in the size of by-pass at which hammer occurs on suddenly opening discharge valve has passed, but the critical point in regard to hammer on "firing" has not yet been reached. Another interesting fact to be noted is that the movable member in the second pattern is also exhibiting a tendency to stick on "firing". The "firing" points are fairly uniform and the curves through them are not so steep as the 1/2" curve.

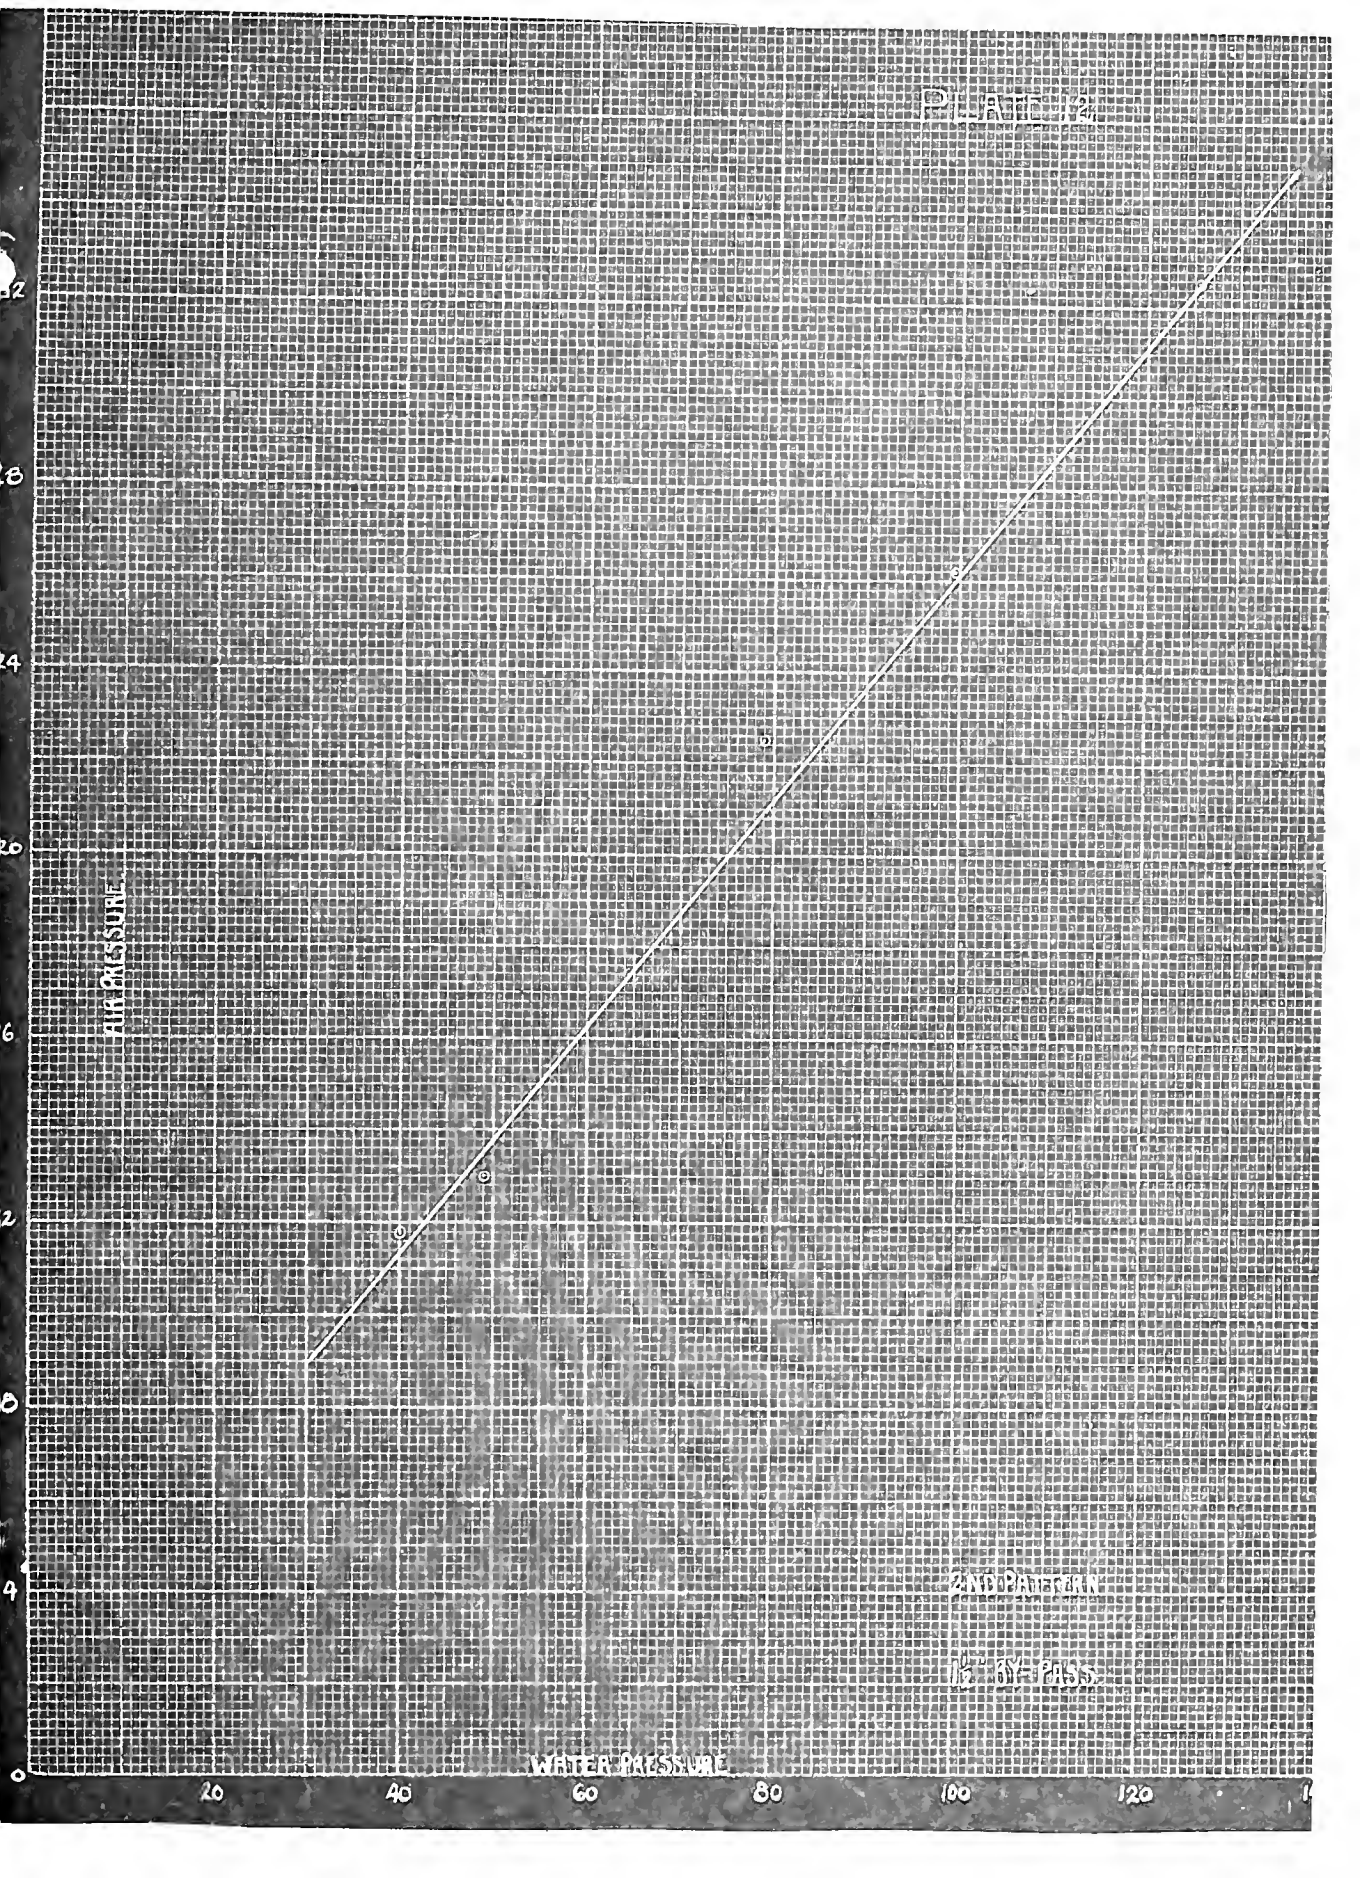
PLATE 12

SECOND PATTERN. ( 1-1/2" by-pass.)

In no instance was water hammer obtained, and the mercury gauge always indicated the larger pressure to be in the lower chamber. This size of by-pass may be considered a safe one, and any addition to this dimension may be considered as a factor of safety.

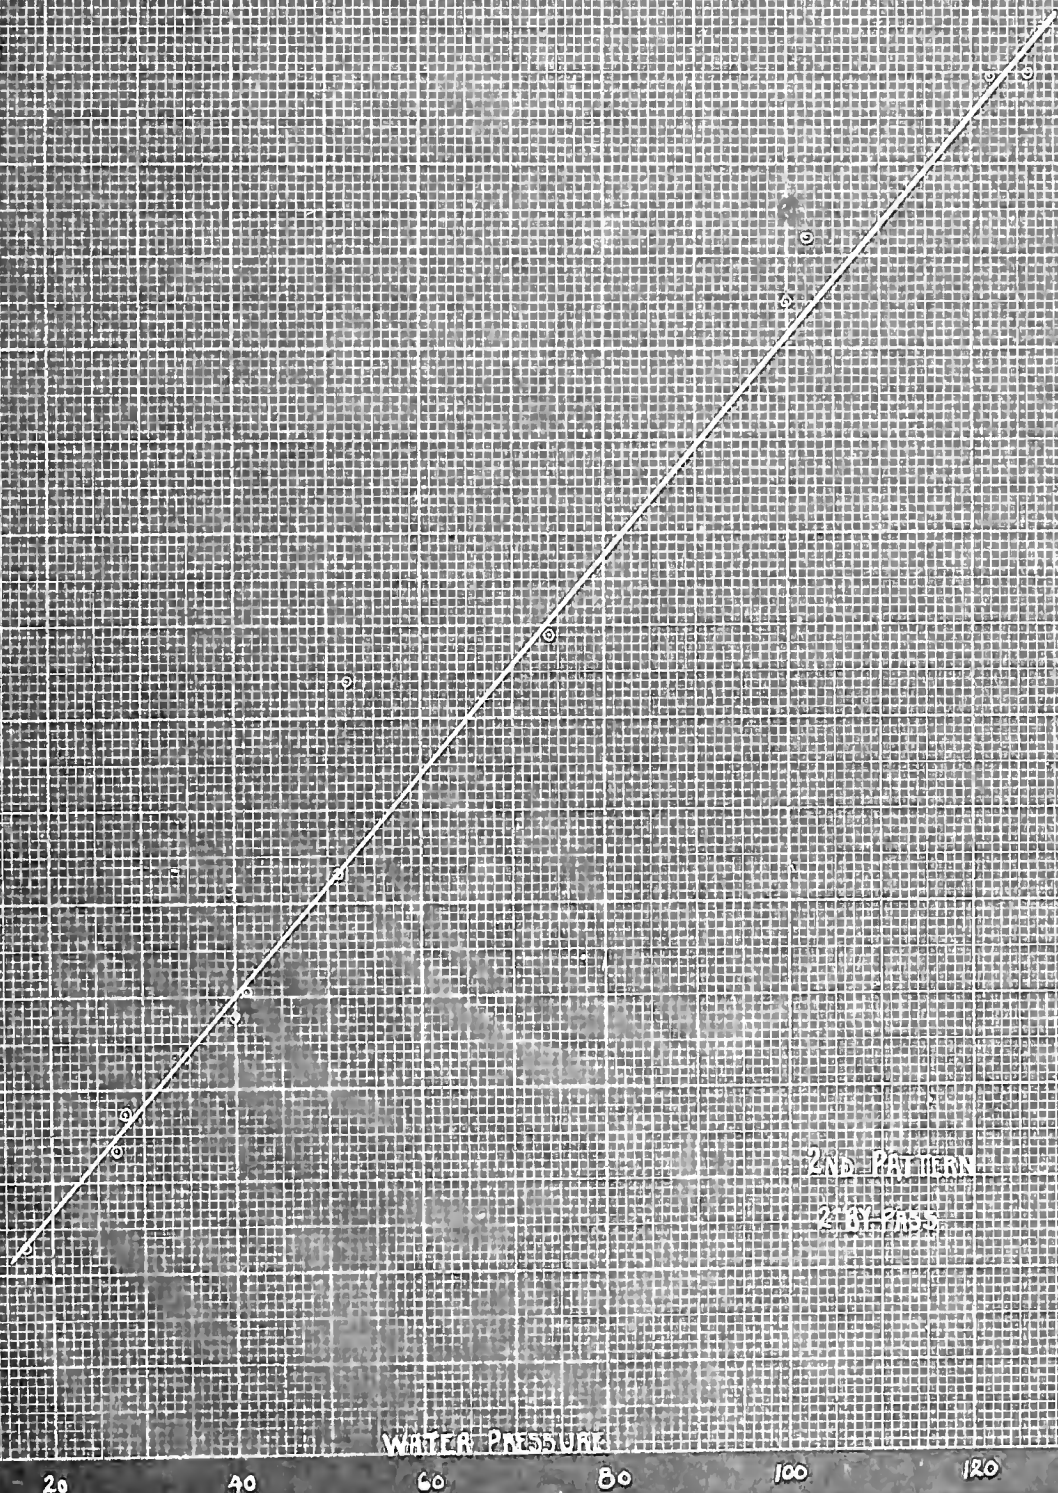
2ND PATTERN  
21 BY PASS

SECOND PATTERN. (2" By-Pass.)

This is the normal by-pass for this pattern, and the tests will prove whether radical change has been made in the action of the valve. At no pressure was there any evidence of water hammer, and in all cases the pressure on the system equalized quickly ( never longer than 15 seconds!)

The mercury gauge in every instance indicated a larger pressure in the bottom chamber than in the upper chamber. Seemingly, the action of the valve with this size by-pass is very satisfactory.
